# It's Official: Quarrying Adds to Biodiversity

## GIS study at Cefn Mawr Quarry demonstrates the added value of rock extraction to nature

By Gerry Lucas, Edge Hill University; Pauline Michell, Michell Ecology; and Noel Williams (retired), Hanson Cement (formerly Castle Cement)

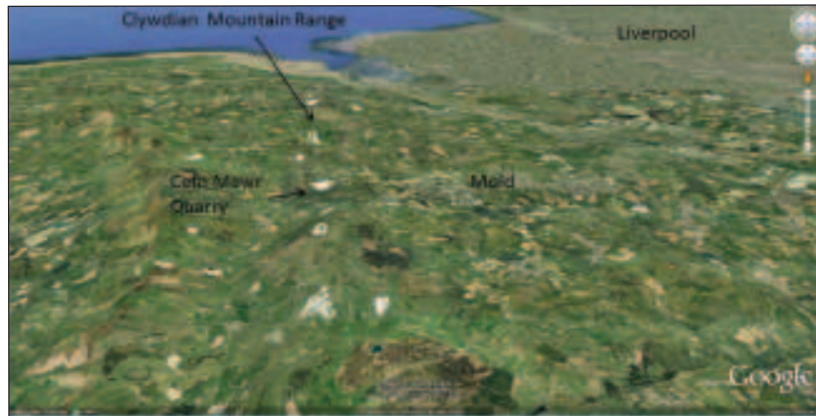
Fig. 1. Northward-looking Google Earth view of the Clwydian mountain range with the limestone quarries situated along the strike of the Carboniferous limestone

A cursory view of the area in Google Earth's 3D mode (fig. 1) illustrates the visual impact that quarrying has had on the area. But one of the motivations behind the study was to measure the degree of impact on ►

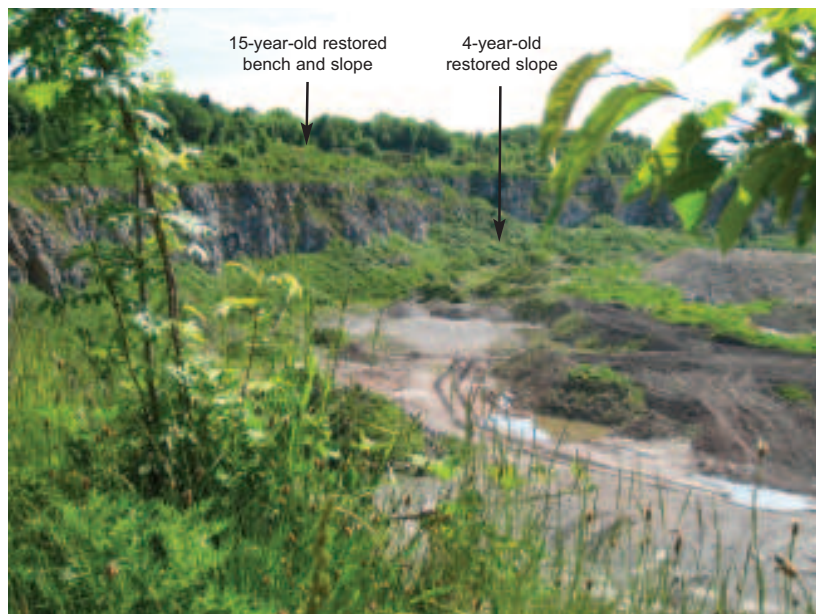
Fig. 2. View of 15- and four-year old restored slopes on the southern limit of the working at Cefn Mawr

Such a process provides immediate visual mitigation and takes with it the floristic and animal species bank. Measurements show that around 80% of the trees survive, including mature individuals. Despite this 'low-tech' mode of operation, these techniques seem to have been very successful at Cefn Mawr (see fig. 2) and preliminary habitat surveys conducted in 2006 confirmed this in terms of the number of floral species present on the restored slopes, with in excess of 40 species present after one year and around 65 species present and stable after 4–15 years.

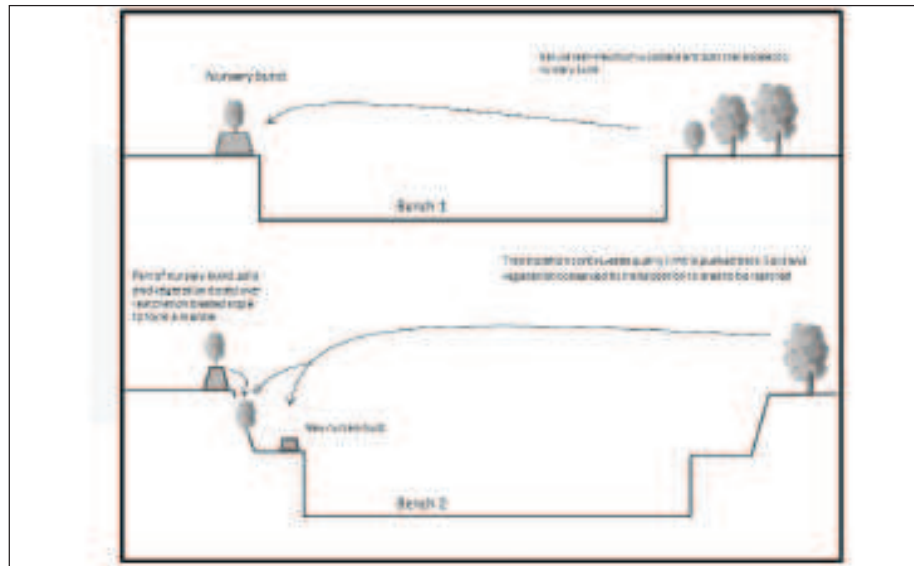
Fig. 3. Diagram showing the Cefn Mawr slope restoration technique

Originally intended as a quarry-based operation to mitigate the visual impact of the site on a hilltop in a landscape-sensitive zone, the methodology developed by the quarry manager, Noel Williams, was fashioned to provide a cost-effective mode of operation as well as to address site concerns for conserving the nature content. Favoured by a relatively thick glacial drift soil (in excess of 1m) overlying the hard rock resource, and with a vegetation substrate of ash-hawthorn woodland or calcareous grassland, the restoration method involved restoration blasting and a somewhat piecemeal and apparently crude method of habitat translocation involving bund-bound temporary nurseries and slope mantling with soils and vegetation.

The in-house slope restoration pioneered by Noel Williams proceeded as shown in figures 3–7.

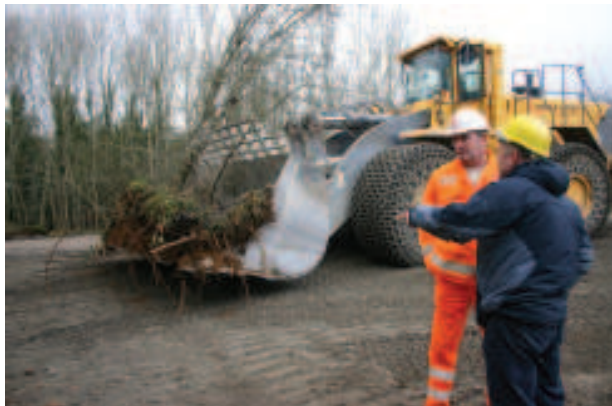
Fig. 4. Eight-tonne shovel picking up a 1m slice of soil and woodland for translocation to nursery bunds and abandoned faces

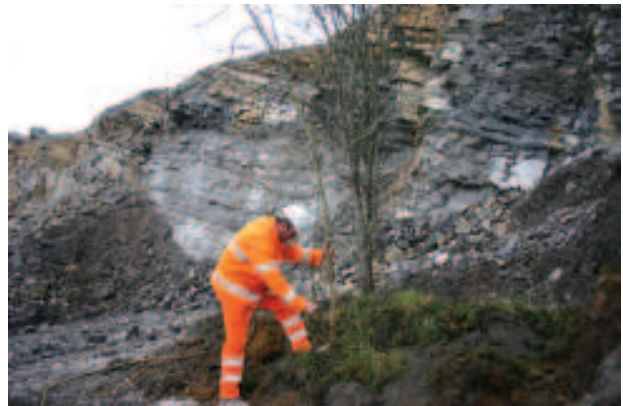
Fig. 5. Minor correction following translocation

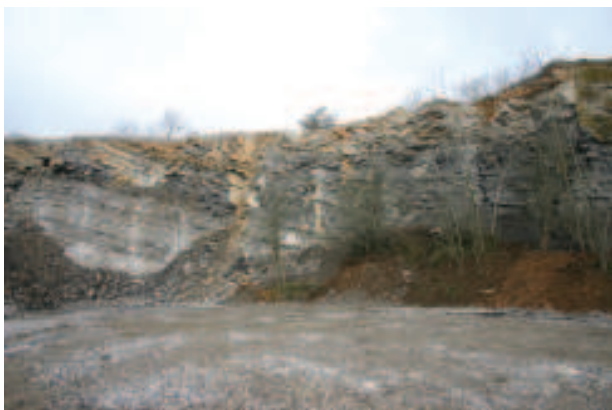
Fig. 6. Restored face at zero months

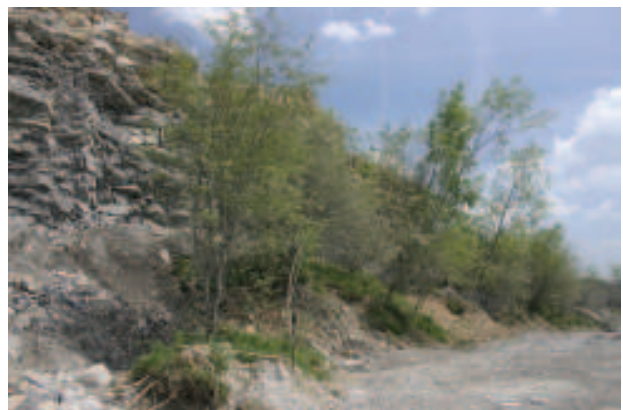
Fig. 7. The same restored face at six months

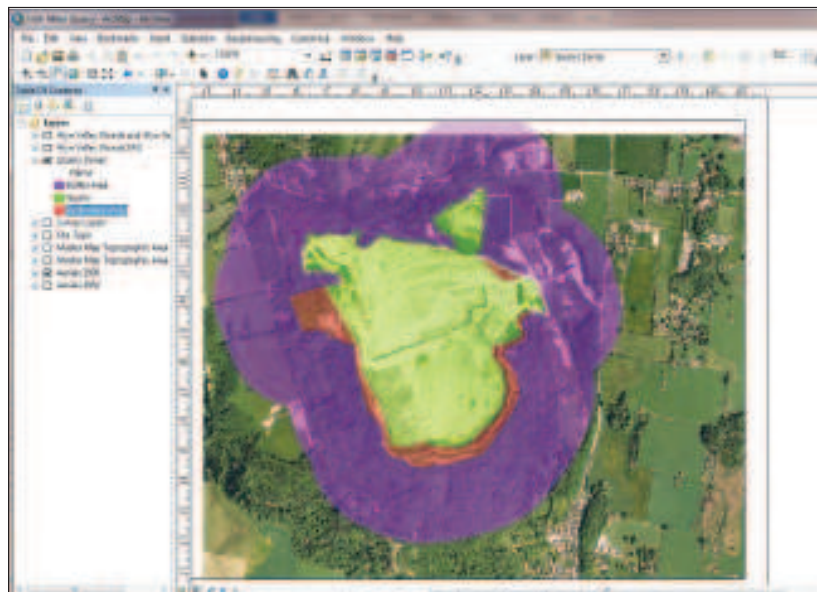
Fig. 8. GIS screen grab of Phase 1 survey showing the operational, restored and 500m buffer zones

To allow a comparison of the site and the impact upon the biodiversity, three survey zones were identified: operational (quarry and plant); restored; and a 500m wide buffer, which effectively encompassed the surrounding countryside (fig. 8).

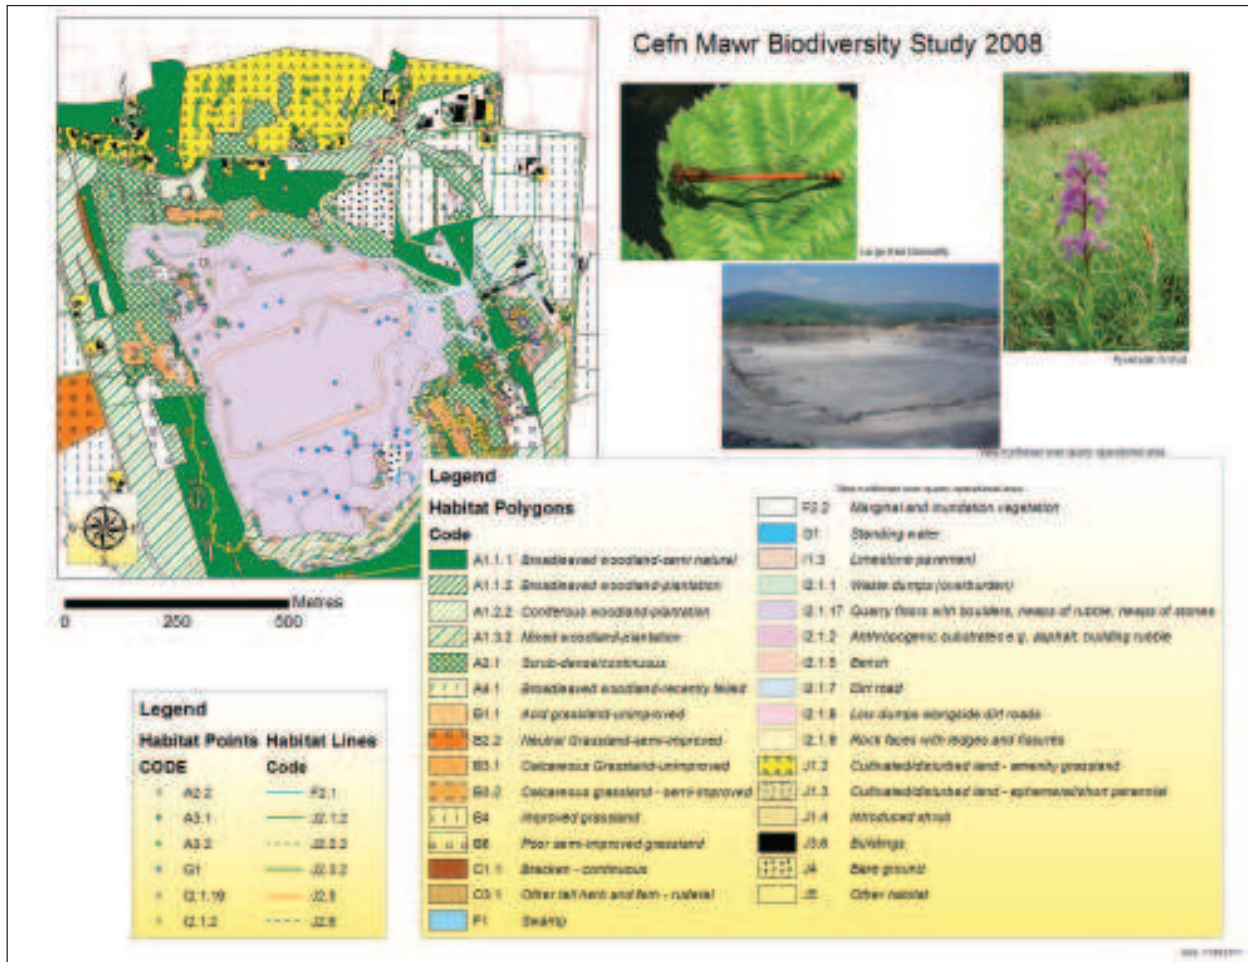
Fig. 9. Phase 1 habitat map of Cefn Mawr Quarry

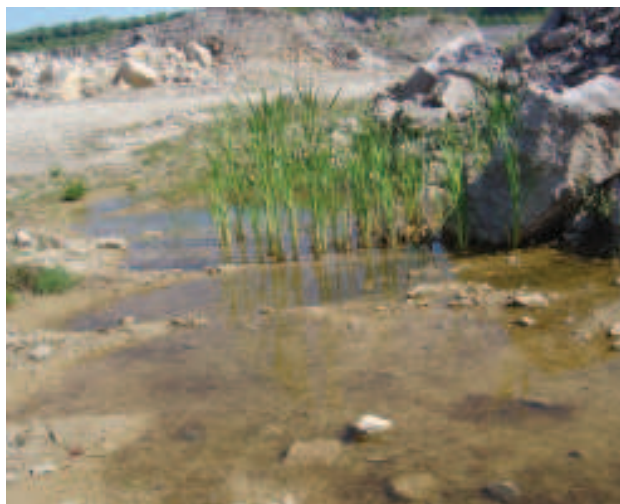
Fig. 10. PLS: a pool of standing water on an access road – ideal for frogs, tadpoles, toads and newts and a myriad of insects

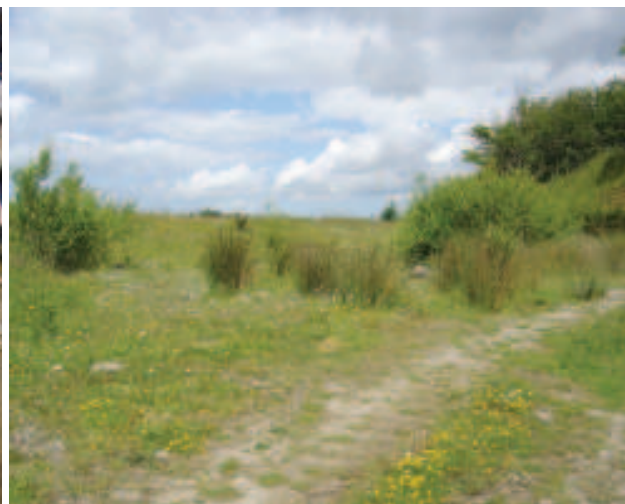
Fig. 11. PLS: an abandoned (not restored) access road – in this case the site of a colony of the nationally rare grizzled skipper butterfly. The dirt tracks around the perimeter of the quarry, particularly in the restored zone, act as wildlife 'rides' for a range of species. The tracks are secured by bunds from the edge of the quarried faces which have developed mixed vegetation, mainly ruderal with scattered scrub. The tracks are similar to, and mimic, the sunken lanes and associated high hedges found in south-west Britain. They are hot in the summer and sheltered during the winter, suiting butterfly and bird species and providing navigation routes for bats and other wildlife
